PROPERTY & LIABILITY ASSESSMENT AUDIT

COMPTON COMMUNITY COLLEGE DISTRICT

RE: ReLiEF PROPERTY & LIABILITY ASSESSMENT FOLLOW-UP AUDIT

SWACC PROPERTY & LIABILITY INSPECTION

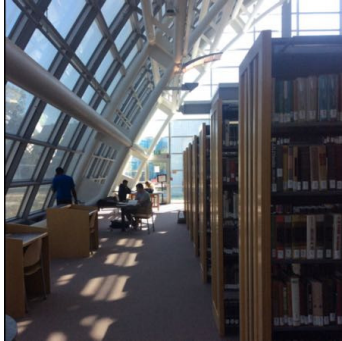
Location: Compton Community College District - COMPTON COMMUNITY COLLEGE - SSC - Library

Description: Exits and emergency evacuation routes should be kept clear of obstructions at all times in order to ensure safe egress. Exit and emergency evacuation routes shall be no less than 30" wide at any point.

Close Note: The obstructions were removed.

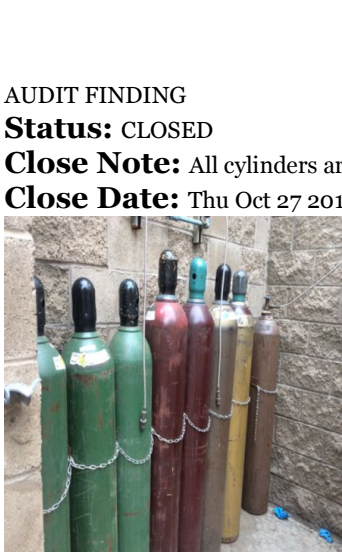
Location: Compton Community College District - COMPTON COMMUNITY COLLEGE - VT Building - Welding

Description: Compressed gas cylinders should always be secured in the upright position with a strong securing device such as a chain, strap or clamp.

Close Note: All cylinders are secured with chains.

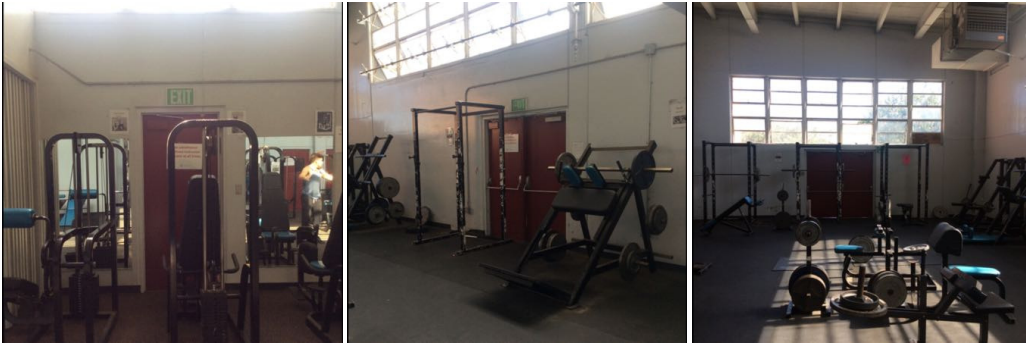
Location: Compton Community College District - COMPTON COMMUNITY COLLEGE - Weight room

Description: Exits and emergency evacuation routes should be kept clear of obstructions at all times in order to ensure safe egress. Exit and emergency evacuation routes shall be no less than 30" wide at any point.

Action Notes: The obstructions were removed, however four out of the six exit doors were locked and require a key to open. One of these four doors is a double door exit with a push bar that is broken on one door. To ensure safe egress, emergency exit doors need to be accessible from inside. Defective exit doors that require excessive force to open or do not function properly should be repaired immediately.

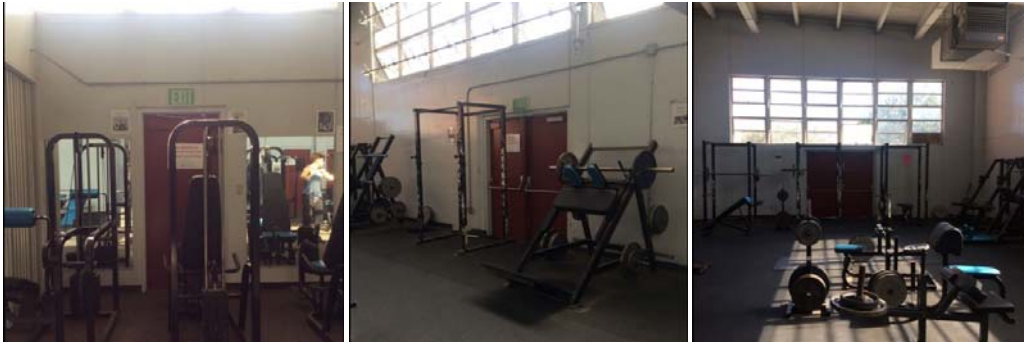
Description: Exits and emergency evacuation routes should be kept clear of obstructions at all times in order to ensure safe egress. Exit and emergency evacuation routes shall be no less than 30" wide at any point.

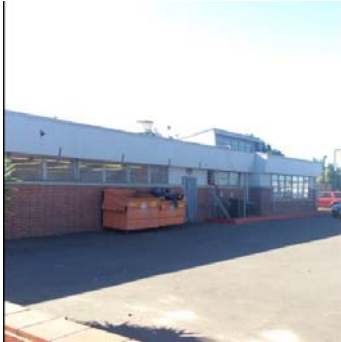
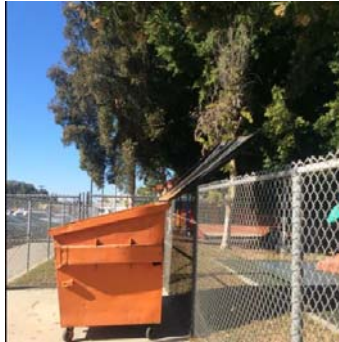
Description: Dumpsters and trash containers should not be stored within 5 feet of any structure to reduce the risk of fire. Dumpsters and trash containers should be secured in a manner that prevents them from being moved near buildings or structures. Dumpster and trash container lids should be locked during off hours. This will reduce the potential of arson related incidents.

Important note: Dumpsters should never be moved near the perimeter fencing of the Child Development Center. Ensure that dumpsters are secured in an enclosed area away from buildings and fencing.

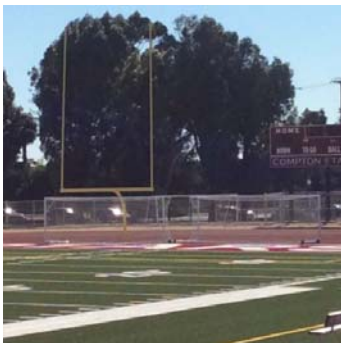
Location: Compton Community College District - COMPTON COMMUNITY COLLEGE - Football
Stadium

Description: Movable soccer goals provide an elevated risk of injury due to struck by or impact injuries. Moveable soccer goals should always be securely anchored or counter-weighted. The District should adhere to recommendations made in the CPSC publication titled "Guidelines for Movable Soccer Goal Safety" to reduce associated hazards.

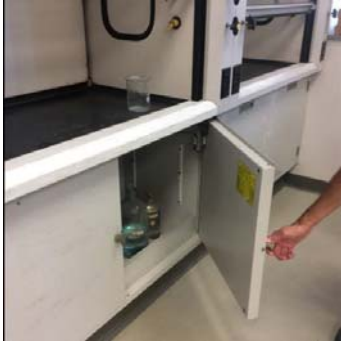
Description: Chemicals should be returned to the designated chemical storage room or area after use. Chemicals should not be stored in classroom labs.

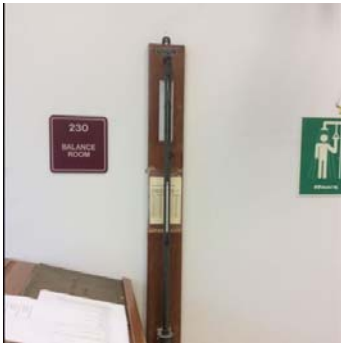
Location: Compton Community College District - COMPTON COMMUNITY COLLEGE - MS 228 Lab Classroom

Description: Chemical spill control kits should be provided and accessible near the mercury thermometer. Employees should be trained on the proper use of chemical spill control kits.

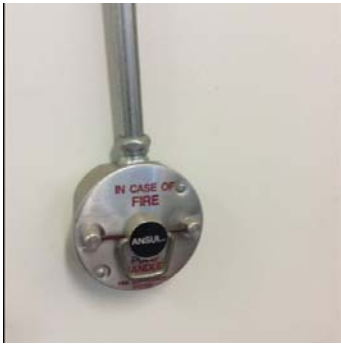
Description: The kitchens Ansul fire suppression system should have a tag indicating that the system

has been serviced in the last 6 months.

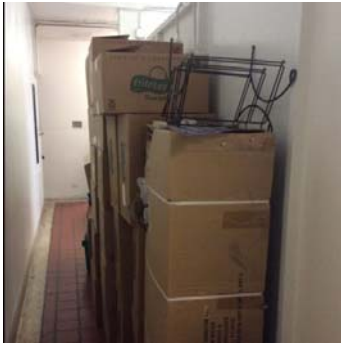
Location: Compton Community College District - COMPTON COMMUNITY COLLEGE - Q Building - Cafeteria/Kitchen

Description: Exits and emergency evacuation routes should be kept clear of obstructions at all times in order to ensure safe egress. Exit and emergency evacuation routes shall be no less than 30" wide at any point.

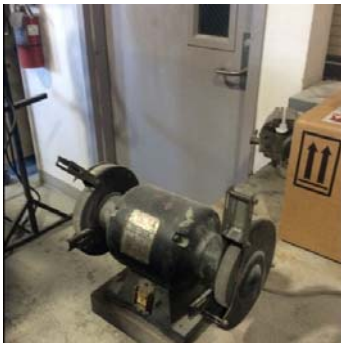
Description: Grinders should be inspected regularly to ensure that tongue guards are attached and adjusted properly, tool rests are attached and adjusted properly, safety shields are attached and adjusted properly and lights are functioning properly. If any equipment is broken or missing the grinder should be taken out of service until it can be repaired.

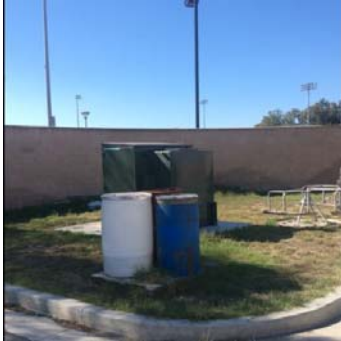
Location: Compton Community College District - COMPTON COMMUNITY COLLEGE - VT Building - Auto Technology - Shop

Description: 1. Hazardous waste storage containers should display a completed EPA approved hazardous waste label. 2. Containers of hazardous waste should be provided with a proper means of secondary containment. 3. Chemical waste areas should remain secured at all times to prevent unauthorized access by students.

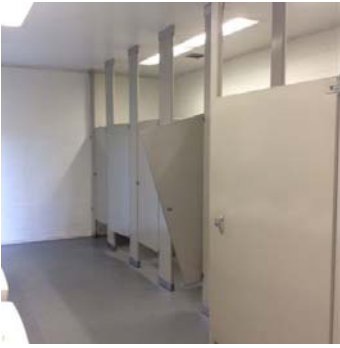
Description: Vandalism and graffiti have been a constant issue in the restrooms. The restrooms should only be made available during practices and sport events and remain locked during after hours.
