Compton Community College District Geotechnical and Soils Investigation Report For Instructional Building #2

PRELIMINARY GEOTECHNICAL INVESTIGATION REPORT PROPOSED NEW INSTRUCTIONAL BUILDING #2 EL CAMINO COLLEGE COMPTON CENTER CAMPUS 1111 E. ARTESIA BLVD. COMPTON, CA 90221

UNITED - HEIDER INSPECTION GROUP PROJECT NO.: 10-18020PW

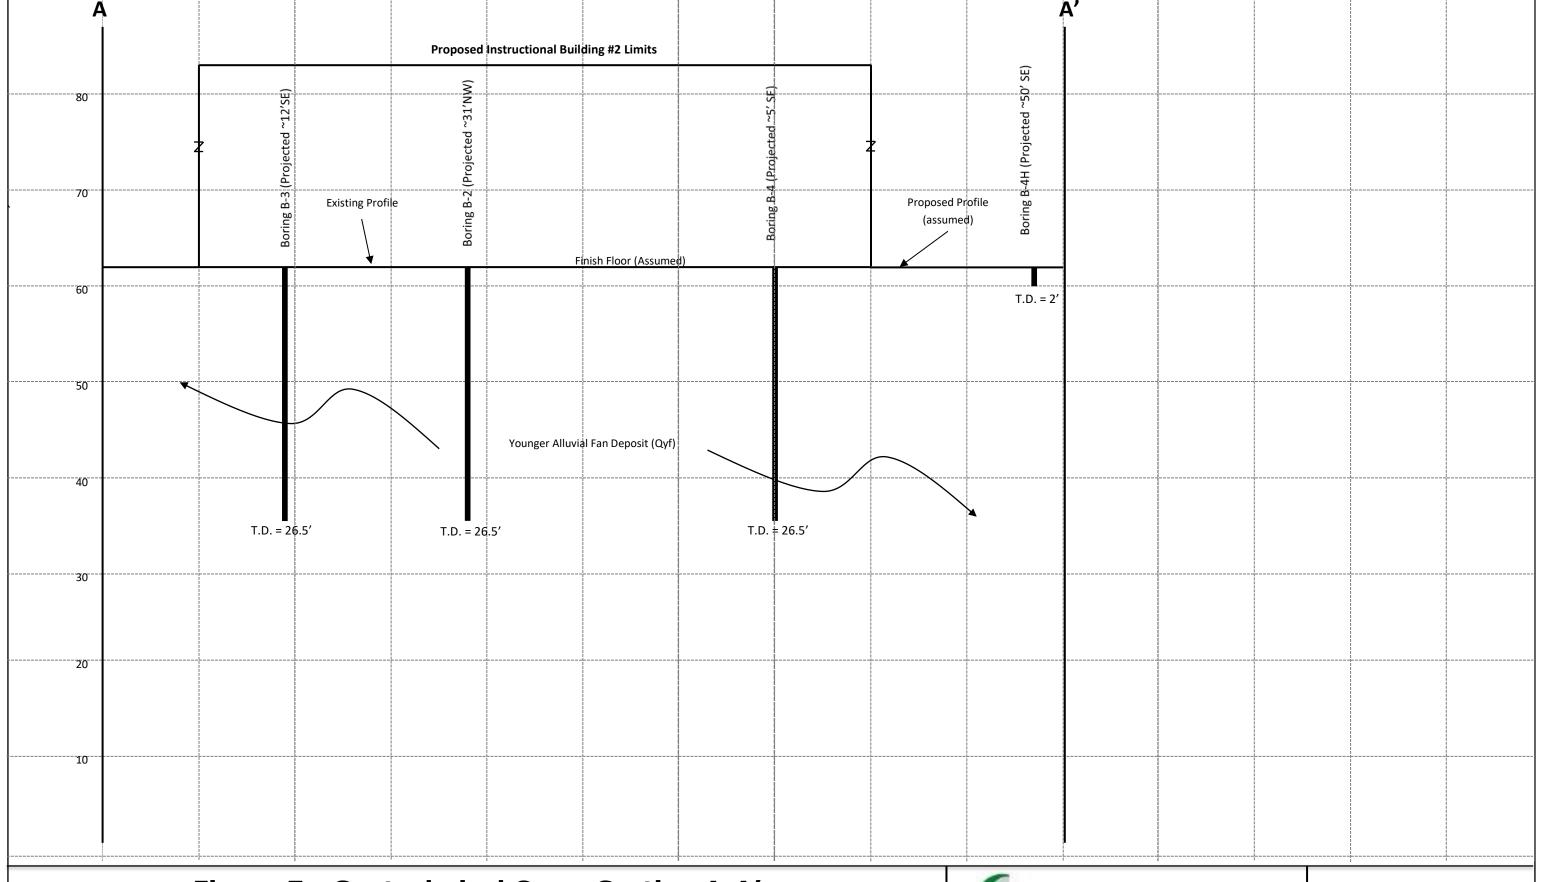
Figure 7 - Geotechnical Cross Section A-A'

Proposed Instructional Building #2

Vertical Scale: 1: 10 Horizontal Scale: 1: 40

The site is underlain by about 0.5 foot of grass/top soil/surficial fill and young alluvial fan deposits of Holocene to late Pleistocene age (Qyf) as shown on the geologic cross sections (Figures 7 and 8 in Appendix A). The young alluvial fan deposits encountered at the site are predominantly comprised of inter-layered Silty SAND, Sandy SILT, Clayey Sandy SILT, Clayey SILT, Silty CLAY, and Sandy Silty CLAY, with lesser amounts of Sandy Clayey SILT and Silty Fat CLAY. In general, the near-surface sandy soils layers are mostly loose to medium dense, and sandy soils layers at depth are medium dense to dense in relative density. The near-surface fine-grained soil layers are mostly firm to stiff and stiff to very stiff at depth in consistency.

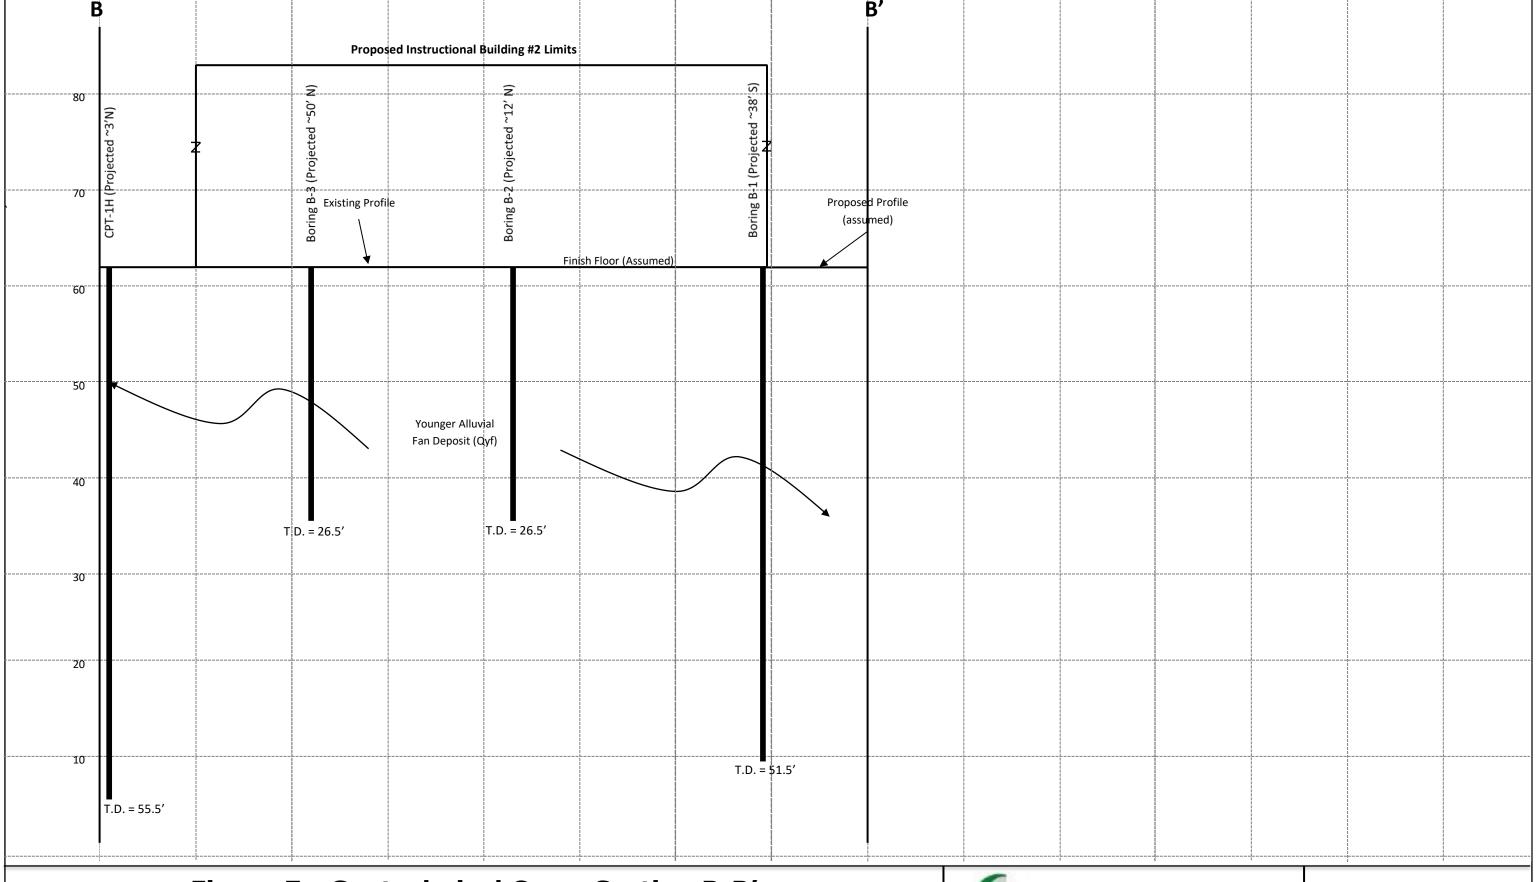
Figure 7 - Geotechnical Cross Section B-B'

Proposed Instructional Building #2

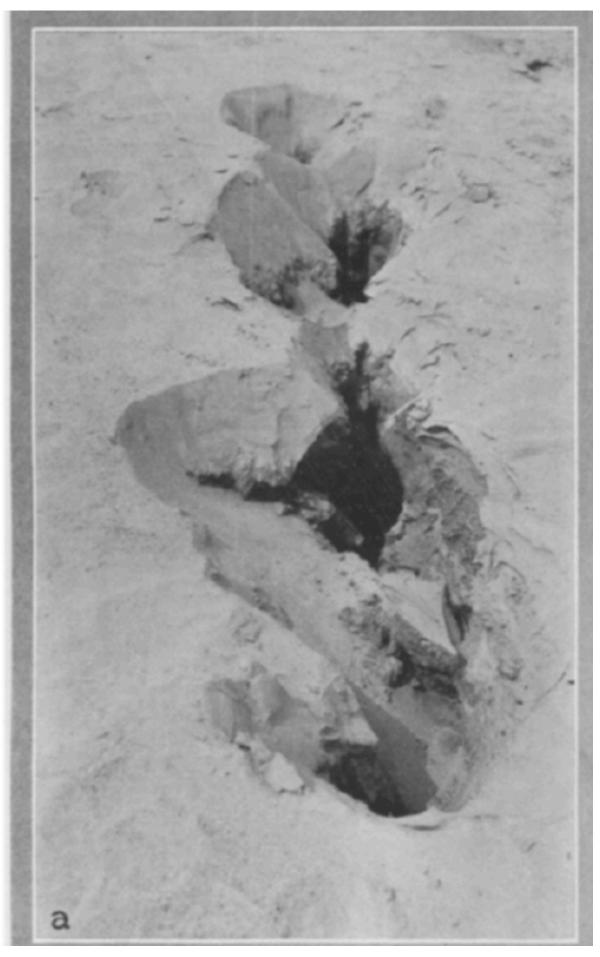
a) Northwest-southeast crack in ground near Compton, showing sand washed out with incipient craterlet development. (Photo courtesy Mr. Donuil Hillis)

In the previous report, the consultants did not address the potential for ground surface disruption, which is reported to have occurred in the vicinity of the college campus following the 1933 Long Beach earthquake. The consultants respond to our comment by presenting additional historical documentation from the Long Beach earthquake. They concluded most of the reported damages were due to seismic shaking/ground motion. However, CGS notes surface effects of liquefaction from the Long Beach earthquake occurred based on references presented in the Seismic Hazard Zone Report for South Gate and depicted in Plate 1.2. The consultants should address additional historical records of ground surface disruption in the area and discuss the hazards posed to the proposed project.
