**Compton Community College District
Geotechnical and Soils Investigation Report
For
Student Services Building Project**

**GEOTECHNICAL INVESTIGATION REPORT
PROPOSED NEW STUDENT SERVICES BUILDING
COMPTON COLLEGE CAMPUS
1111 E. ARTESIA BLVD.
COMPTON, CA 90221**

PROJECT NO.: 10-18469PW

Subject: Geotechnical Investigation Report
Proposed New Student Services Building
Compton College Campus
1111 E. Artesia Boulevard
Compton, CA 90221

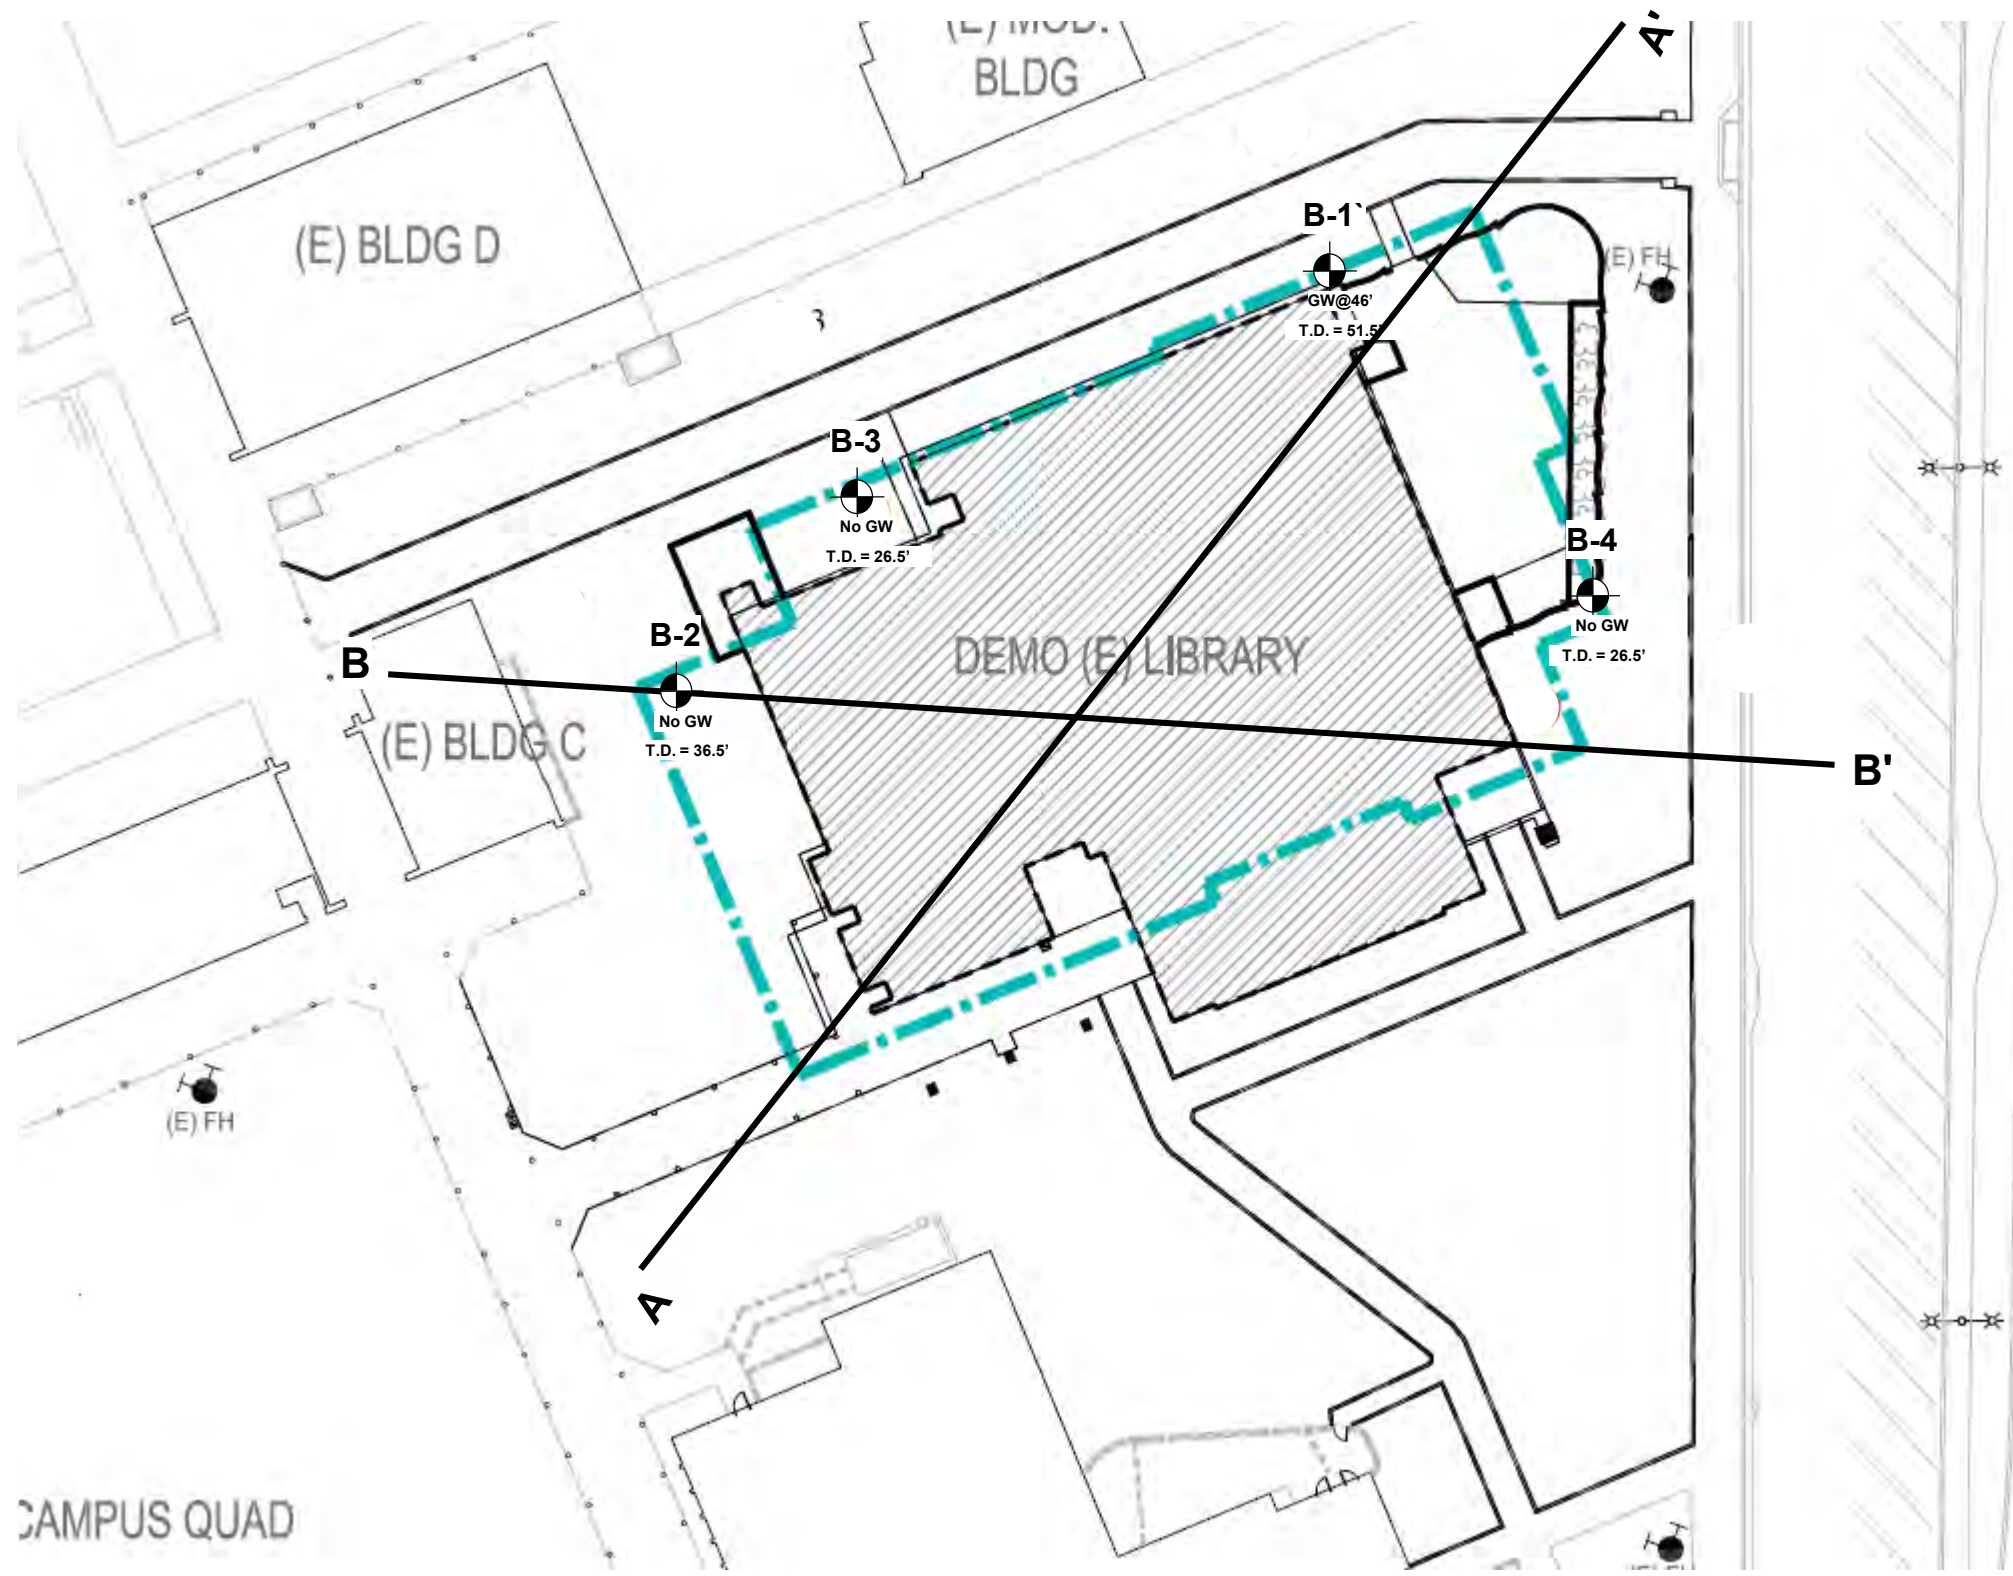
Figure 2 – Boring Location Map
Proposed New Student Services Building
Compton College Campus
1111 East Artesia Blvd.
Compton, CA 90221

EXPLANATION

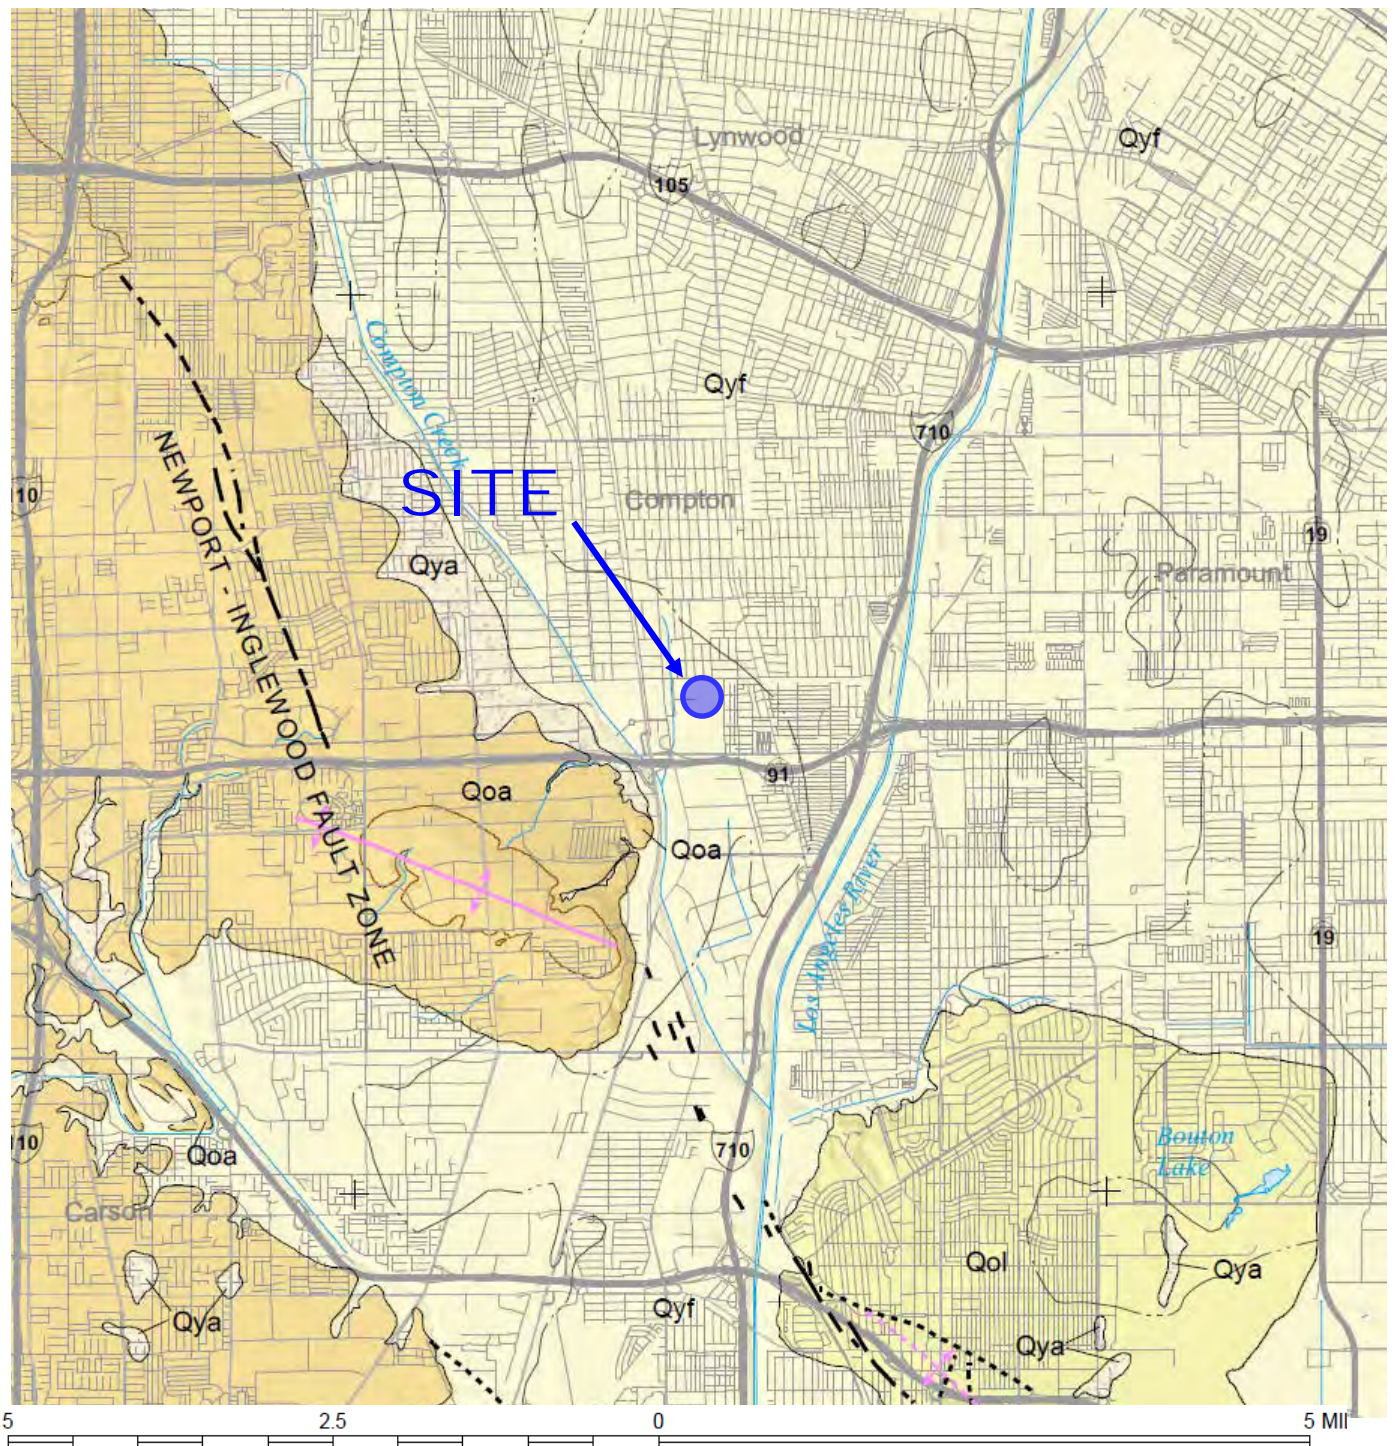
Qyf Young Alluvial Fan Deposits - unconsolidated to slightly consolidated, undissected to slightly dissected boulder, cobble, gravel, sand, and silt deposits issued from a confined valley or canyon

REFERENCE: CGS (2010) Geologic Compilation of Quaternary Surficial Deposits In Southern California Onshore Portion Of The Long Beach 30' X 60' Quadrangle; CGS Special Report 217, Plate 8.

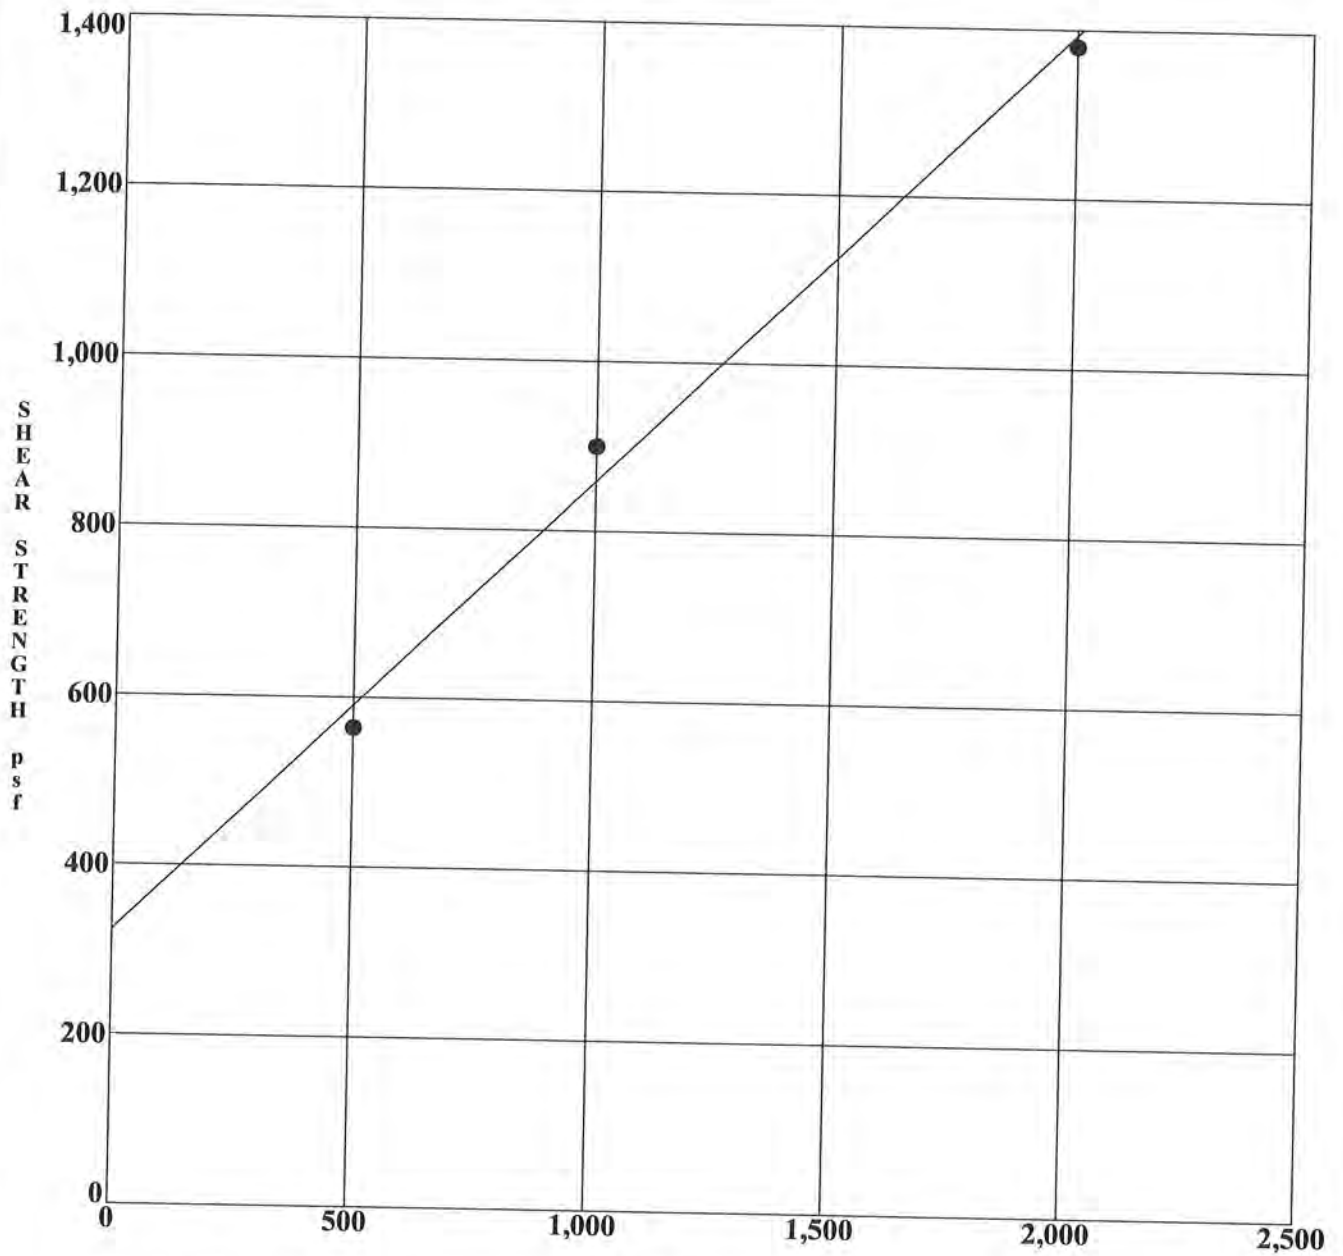
SHEAR TEST DIAGRAM
 LOR Geotechnical Group, Inc.
 Riverside, CA 92507

Cohesion Calc. (psf): 324
 Friction Angle Calc. (°): 28

NORMAL PRESSURE, psf

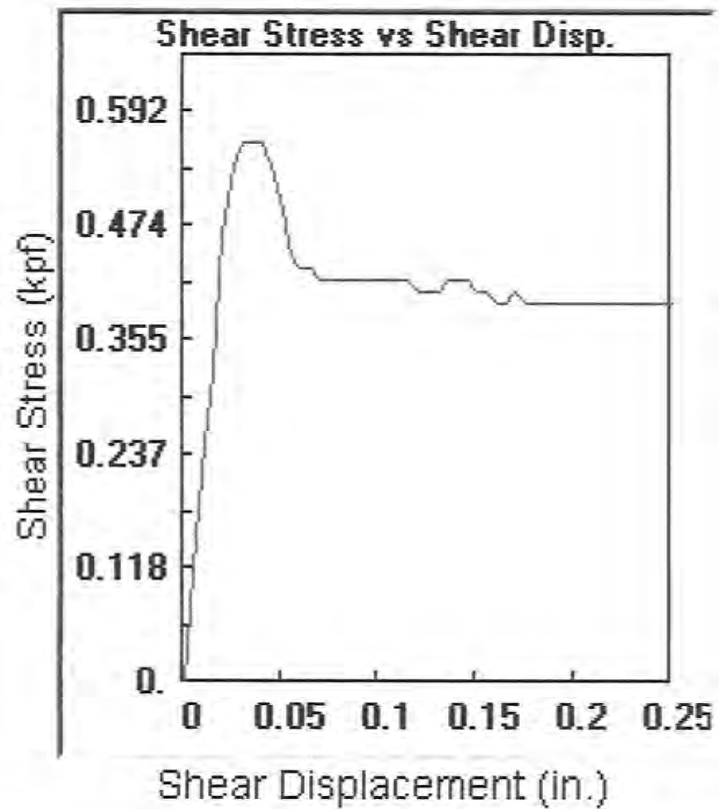
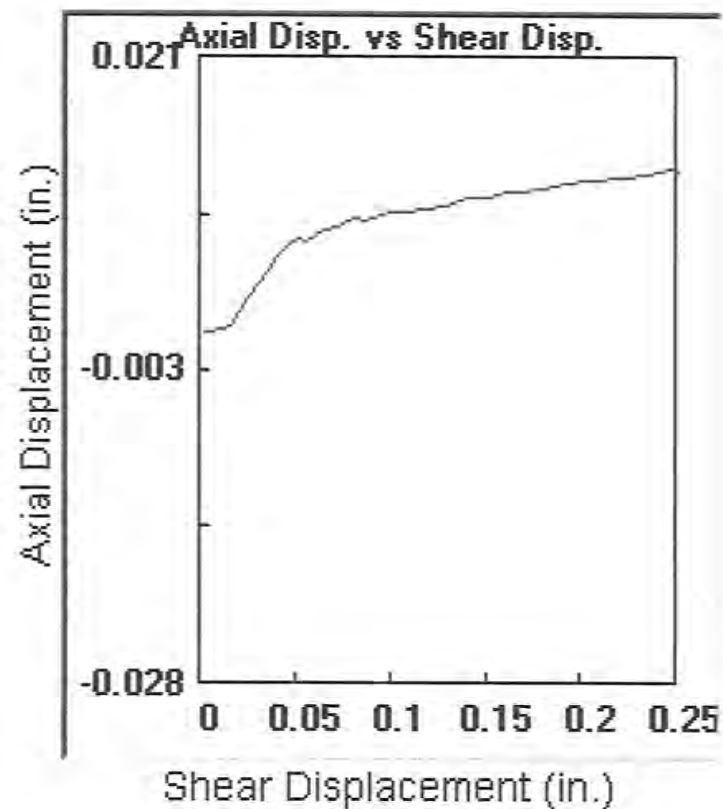
Parameters							
Client: UNITED-HEIDER INSPECTION GROUP							
Location: COMPTON COLLEGE NEW STUDENT SERVICE							
Job # 10-18469	Soil Type:						
Sample: B-4@2.5'	Technician: MARK						
Boring: B-4	Axial Load: 500 psf						
Depth: 2.5 ft.	Shear Rate: 0.01 in./min.						
File:	Distance: 0.25 in.						
Stress at Max Def 564 0.03	Stress at Max Disp 0.245 396

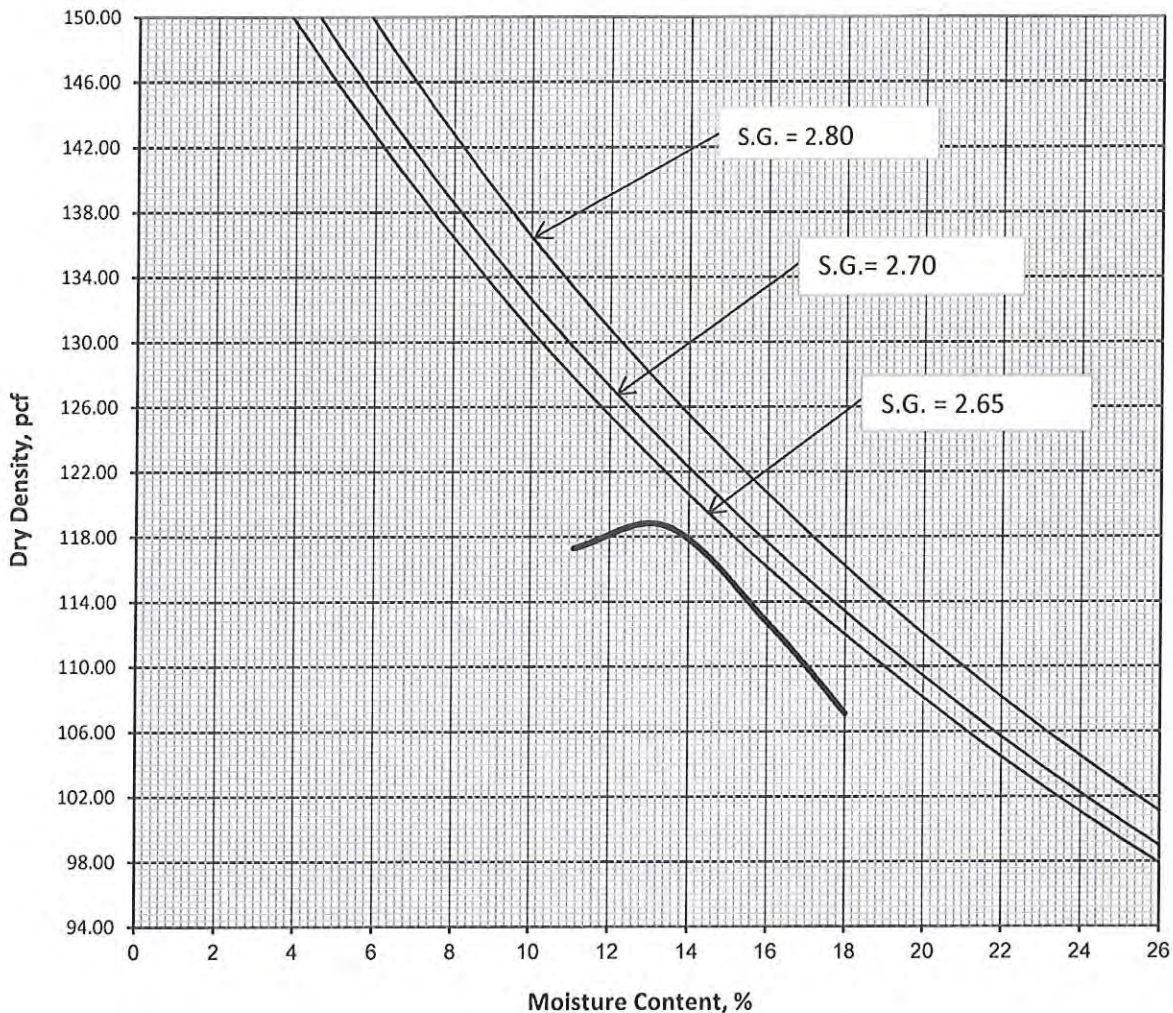
Maximum Density - Optimum Moisture Content, ASTM D 1557

Lab Sample No.:	10S181012-1	Test Results:	
Visual Class.:	Tan Slightly Sandy SILT with little Pea gravel	Maximum Dry Density, pcf:	118.4
Sample Source:	B-4 @ 2.5'	Optimum Moisture Content, %:	13.5
Method of Test:	ASTM D 1557

The maximum dry density and optimum moisture content of a representative bulk soil sample were determined in accordance with ASTM Test Method D1557. Test results and a graphical plot of maximum density vs. optimum moisture content are attached in this appendix.

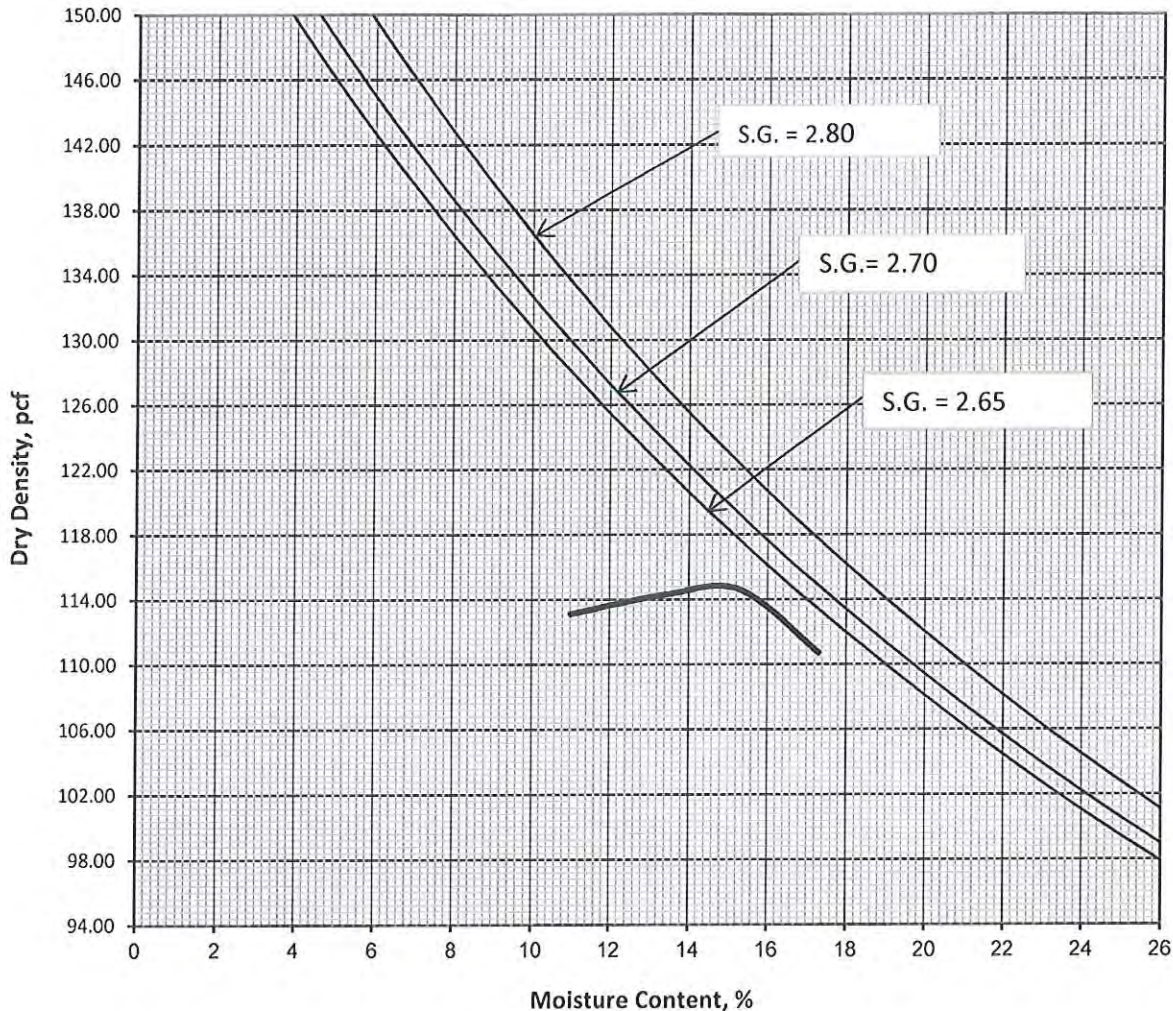
Maximum Density - Optimum Moisture Content, ASTM D 1557

Test Results:
Maximum Dry Density, pcf: 114.6
Optimum Moisture Content, %: 15.3

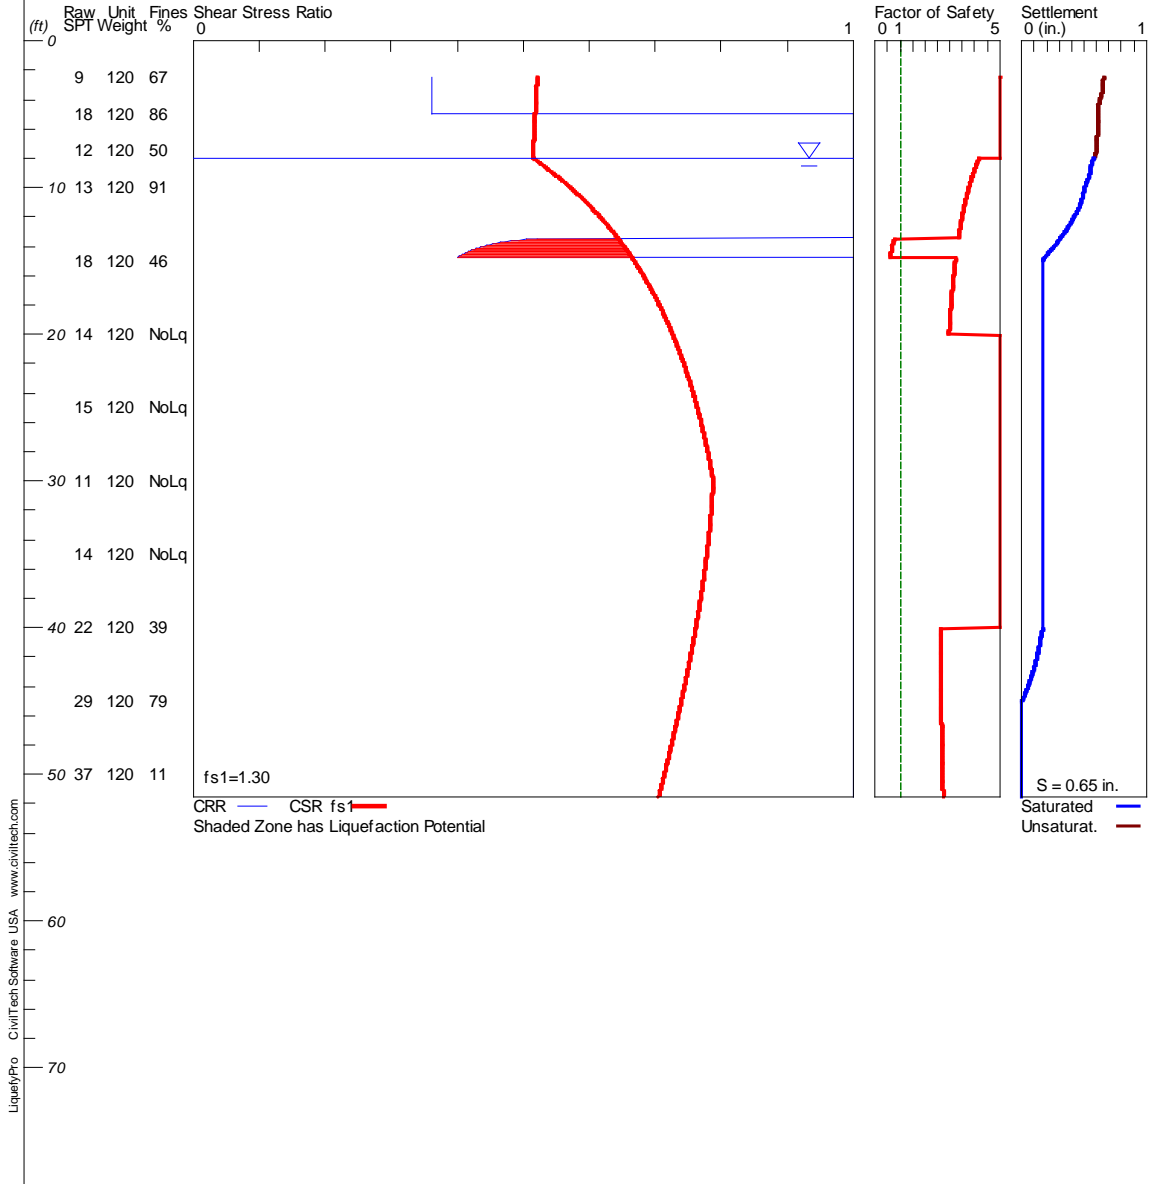
Hole No.=B-1 Water Depth=8 ft Surface Elev.=1000

Magnitude=7.3
Acceleration=0.62g

A site-specific liquefaction analysis was performed in accordance with the method of NCEER (Youd et al., 2001) and Boulanger and Idriss (2006) using LiquefyPro Version 5 computer program developed by Civiltech Software. Seismically-induced settlement analyses were performed based on the sub-surface conditions encountered in the deep boring B-1 and peak ground acceleration values PGA corresponding to adjusted Peak Ground Acceleration PGA_M . For this analysis, we considered a historic high groundwater level at eight feet below ground surface as indicated on the CGS Seismic Hazards Report. The predominant earthquake magnitude was obtained from the USGS Interactive Deaggregation website for a 2% probability of exceedence in 50 years (2475 return period) hazard. The seismic parameters, using peak ground acceleration values PGA corresponding to adjusted Peak Ground Acceleration $PGAM$ and modal magnitude of 7.3 Mw, were used for the liquefaction analysis. Seismically-induced settlement calculated for the soil layers has the factor of safety of less than 1.3.

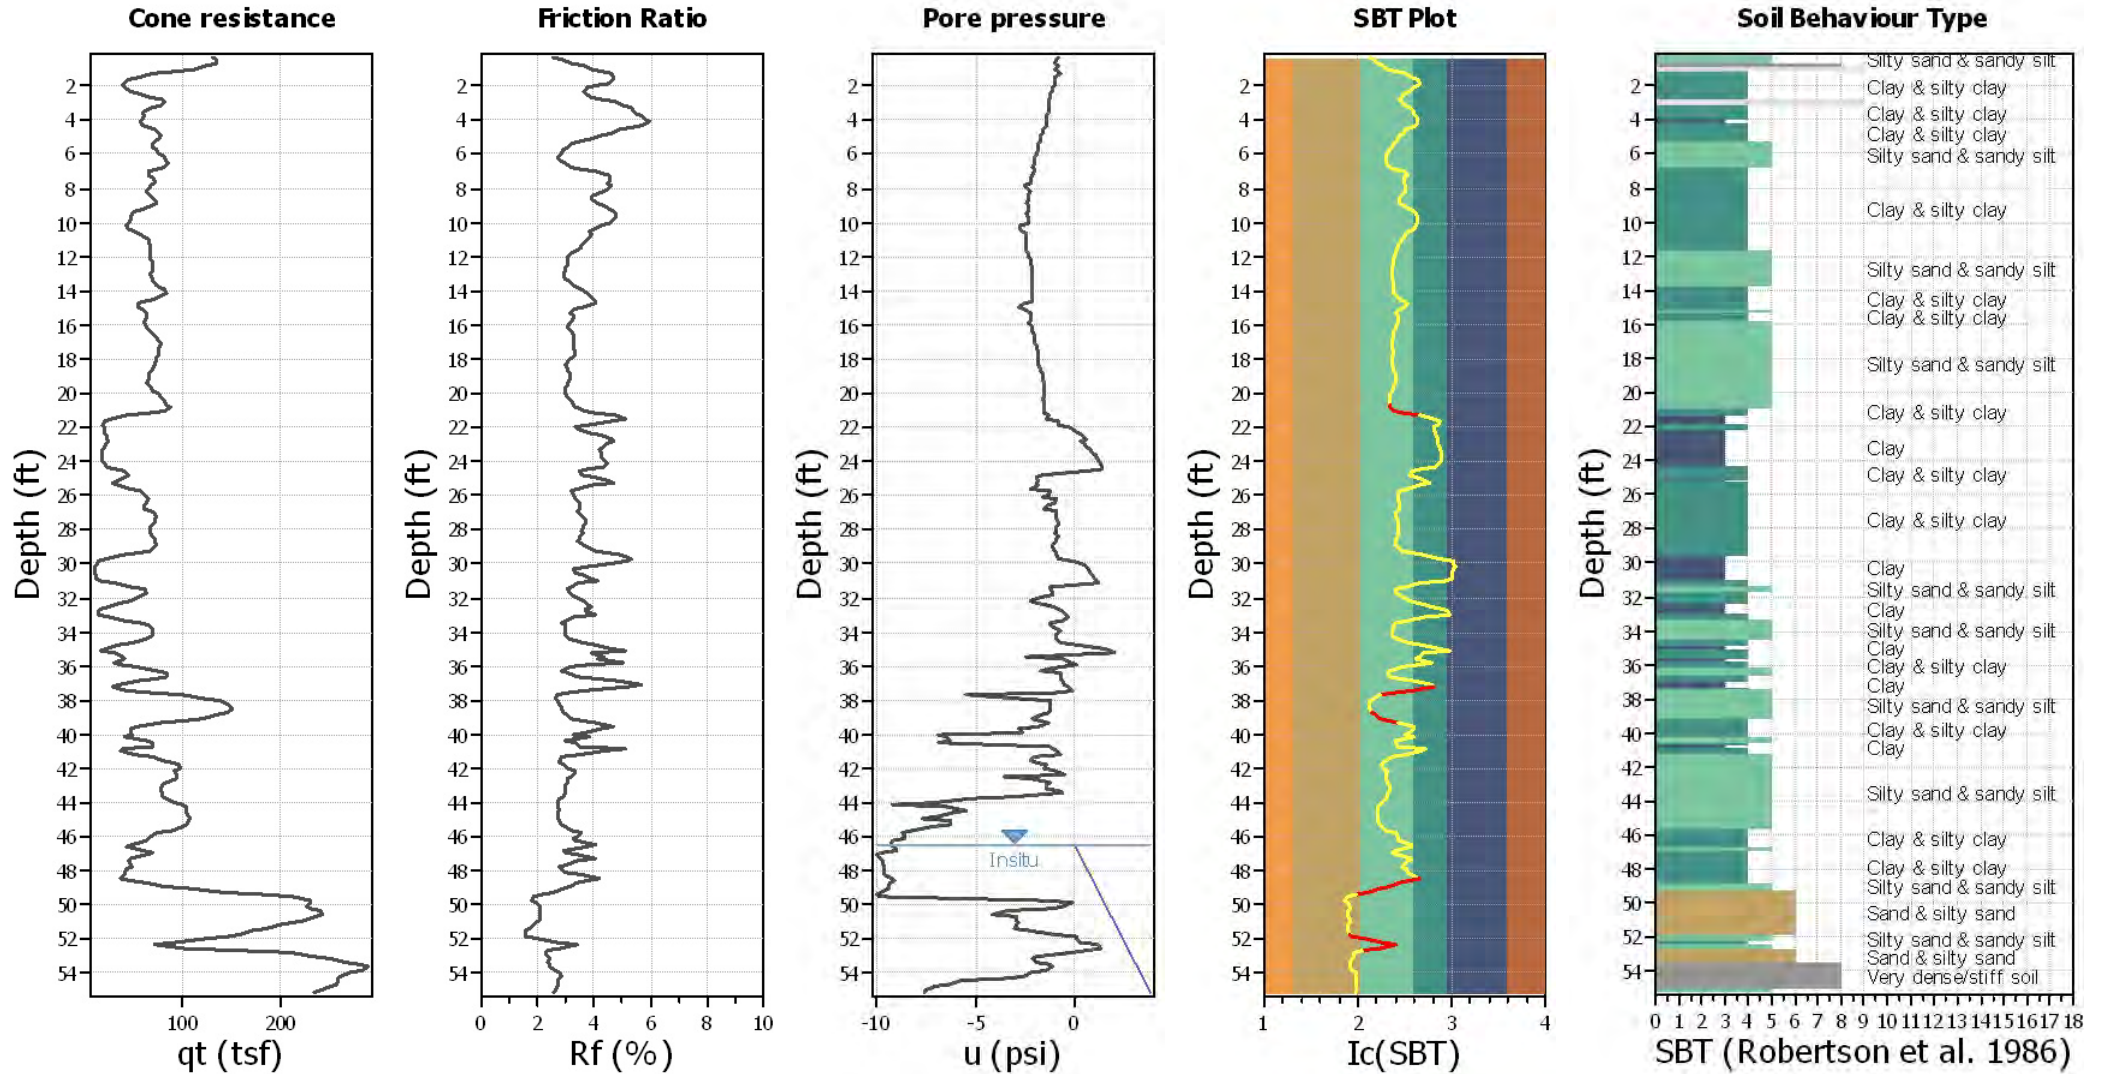
CPT basic interpretation plot

Analysis method:	NCEER (1998)	Depth to water table (erthq.):	8.00 ft	Fill weight:	N/A
Fines correction method:	NCEER (1998)	Average results interval:	3	Transition detect. applied:	Yes
Points to test:	Based on Ic value	Ic cut-off value:	2.60	K_0 applied:	Yes
Earthquake magnitude M_w :	7.30	Unit weight calculation:	Based on SBT	Clay like behavior applied:	Sands only
Peak ground acceleration:	0.62	Use fill:	No	Limit depth applied:	No
Depth to water table (insitu):	46.40 ft	Fill height:	N/A	Limit depth:	N/A

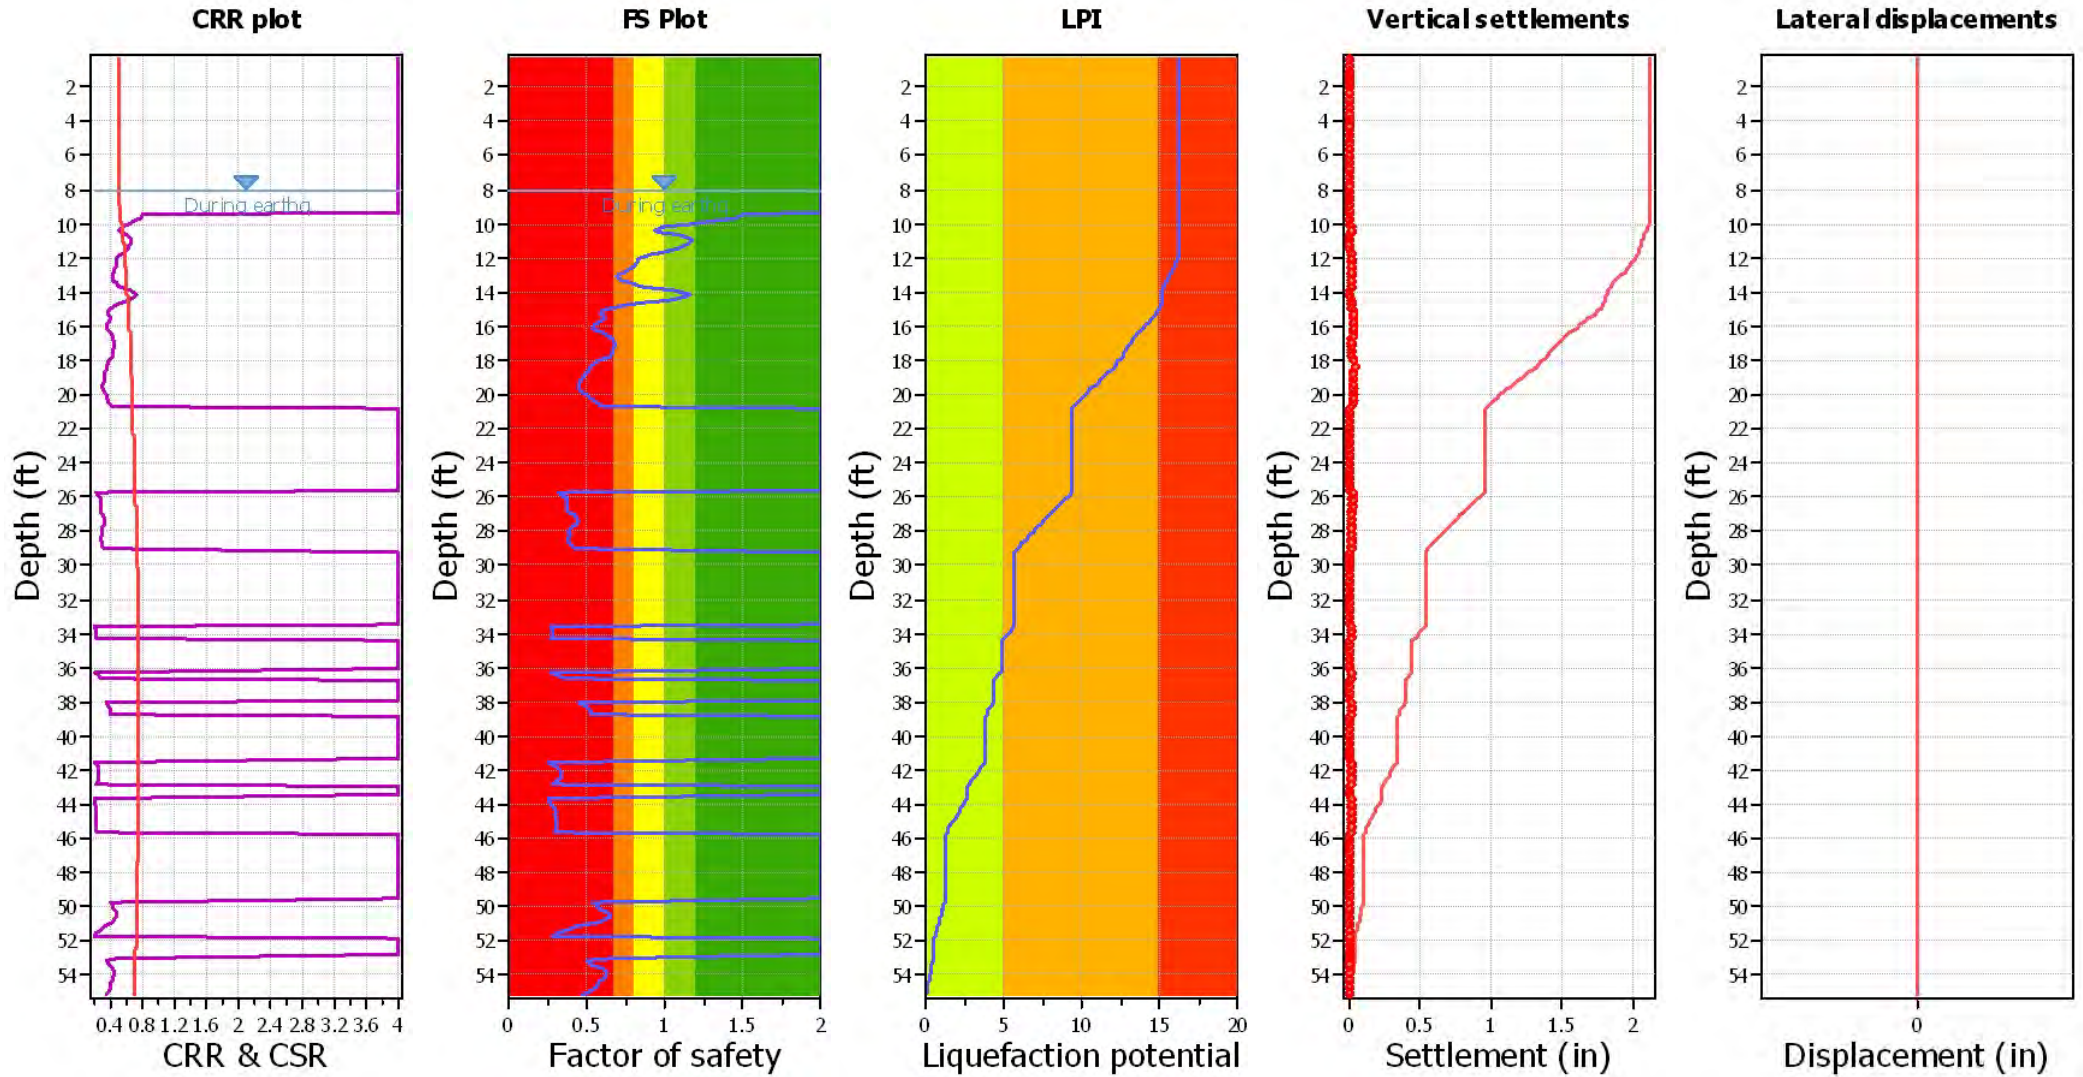
Liquefaction analysis overall plot

Analysis method:	NCEER (1998)	Depth to water table (earthq.):	8.00 ft	Fill weight:	N/A
Fines correction method:	NCEER (1998)	Average results interval:	3	Transition detect. applied:	Yes
Points to test:	Based on Ic value	Ic cut-off value:	2.60	K_{σ} applied:	Yes
Earthquake magnitude M_w :	7.30	Unit weight calculation:	Based on SBT	Clay like behavior applied:	Sands only
Peak ground acceleration:	0.62	Use fill:	No	Limit depth applied:	No
Depth to water table (insitu):	46.40 ft	Fill height:	N/A	Limit depth:	N/A
